PLACIDO BAYOU

PHASE I AND II LAKE BANK RESTORATION & STABILIZATION REPORT

Prepared for:
PLACIDO BAYOU LAKE COMMITTEE

CHARLOTTE ENGINEERING & SURVEYING, INC.

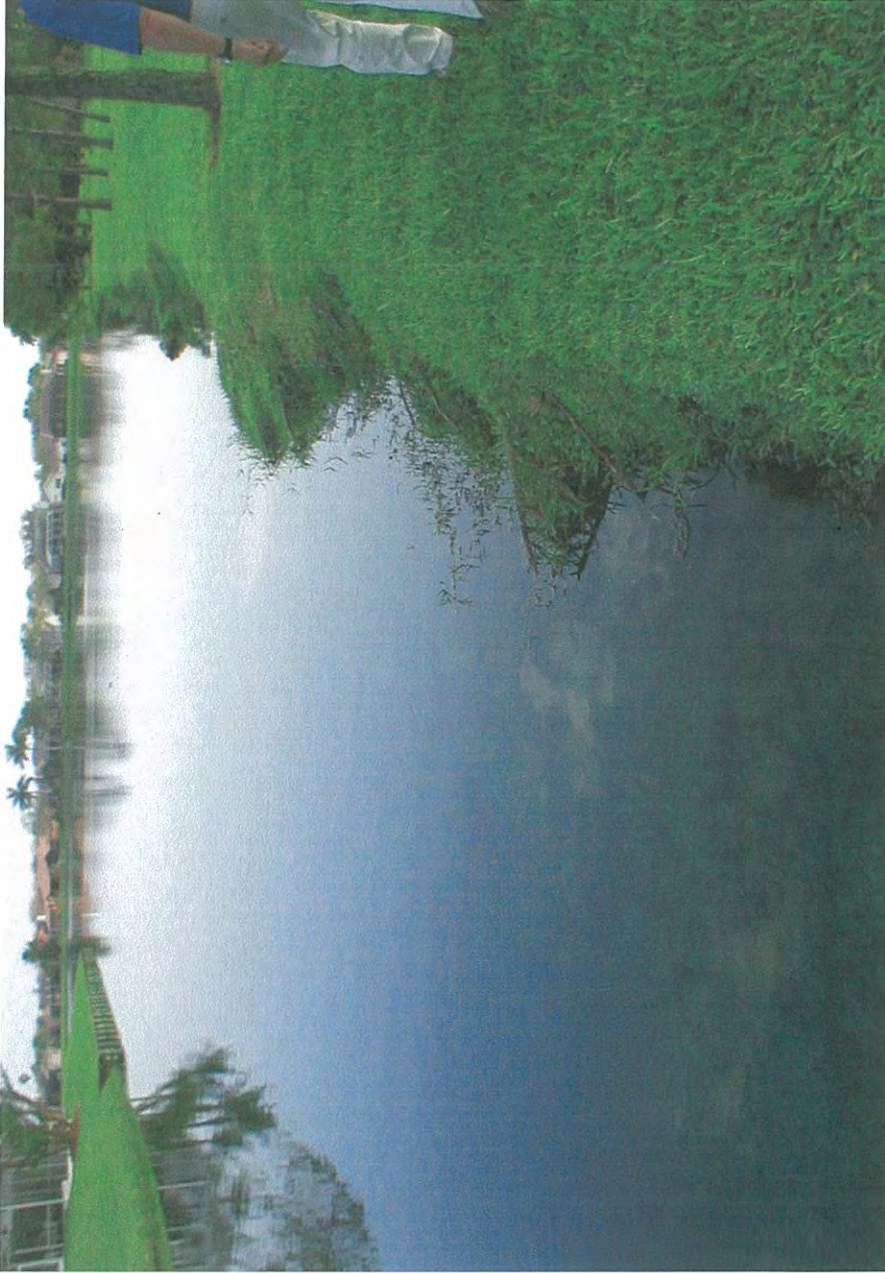
PHOTO 1

Over the years, the natural process of continued bank erosion has occurred. In many locations, the edges of the lakes have expanded by 10 feet or more beyond the original bank edge. Photo 1 shows a typical condition of the eroded lake edge. Note that the grass extends to the water's edge and is being continually undermined by the wave action on the lake. This results in a slow but continued collapse of the lake edge as well as its outward migration. Photo 2 shows a culvert headwall that originally was located at the edge of the lake. Note that the headwall is now 10 feet beyond the existing waters edge. In several of the lakes, the erosion has been so extensive that backyards and pool decks were being undermined. In order to prevent further erosion, the edges of the lakes in many areas have been protected with seawalls. This provides a hard edge to the lakes with no opportunity for vegetation to grow at the waters edge. See Photo 3.

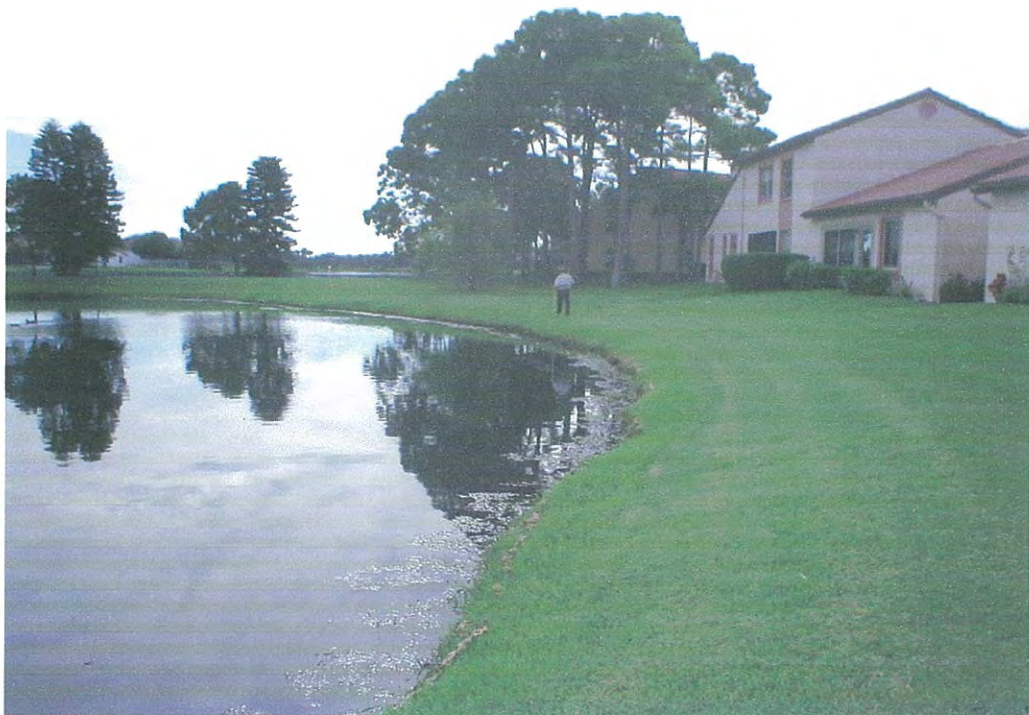
SEGMENT 6

Segment 6: The edge of the lake in this segment is moderately eroded; no structures in this segment are in immediate risk. Dense planting and a pre-vegetated plant mat, the coir fiber matrix system, or the coir rolls systems (turtle logs) should be installed to prevent further loss of bank material.

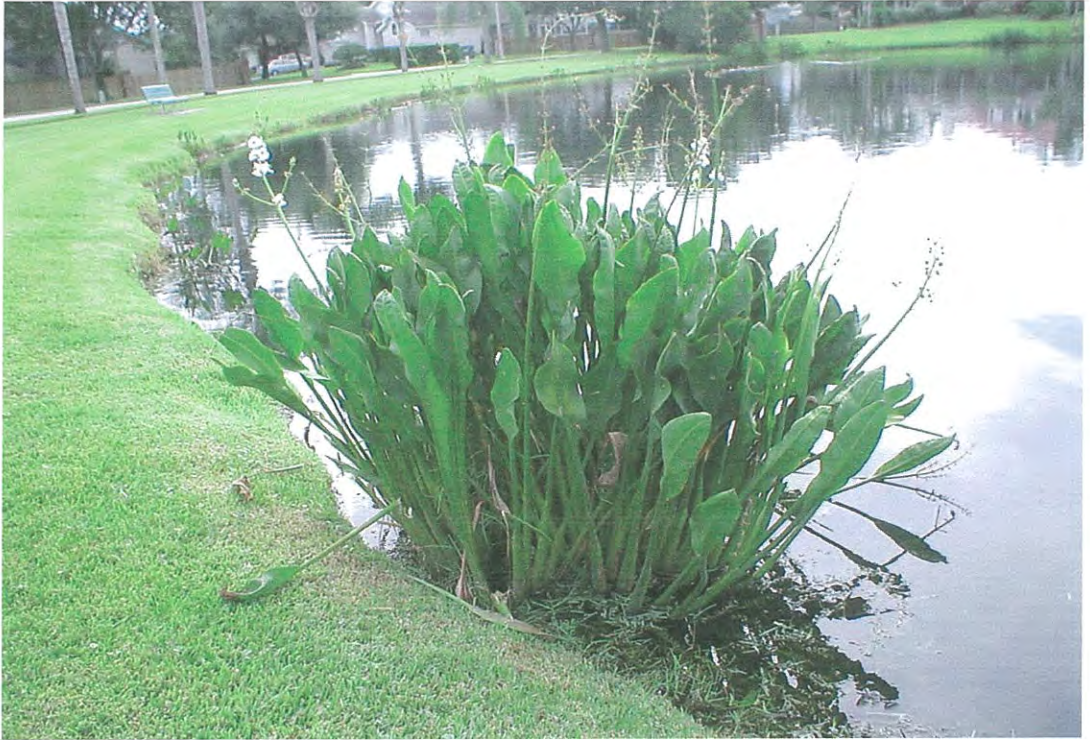
SEGMENT 5

Segment 5: The edge of the lake in this segment is moderately eroded; no structures or roads are in immediate risk. The lake bank slope in this segment is relatively flat. Dense planting or the coir fiber matrix system installed along the shoreline should be sufficient to prevent further loss of bank material.

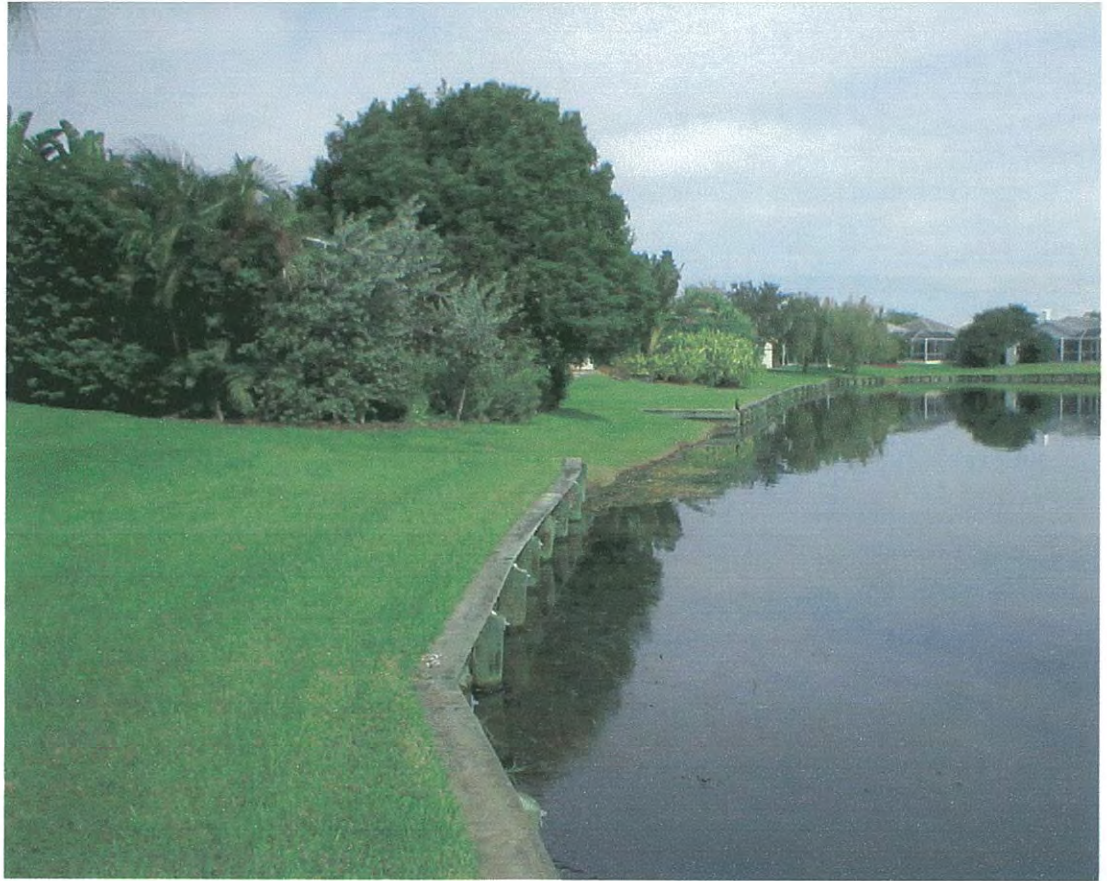
GENERAL VIEW

Over ninety percent of this lake is protected by pressure-treated wood retaining walls. Only two lots along the lake have unprotected shorelines. Since these two lots are between segments of the lake where vertical retaining walls have been constructed and due to the short section of unprotected lake edge, a continuation of the retaining wall is recommended for these segments. Additional fill should be added in these areas to restore the lake bank to near original conditions. These areas have very limited room for construction access.

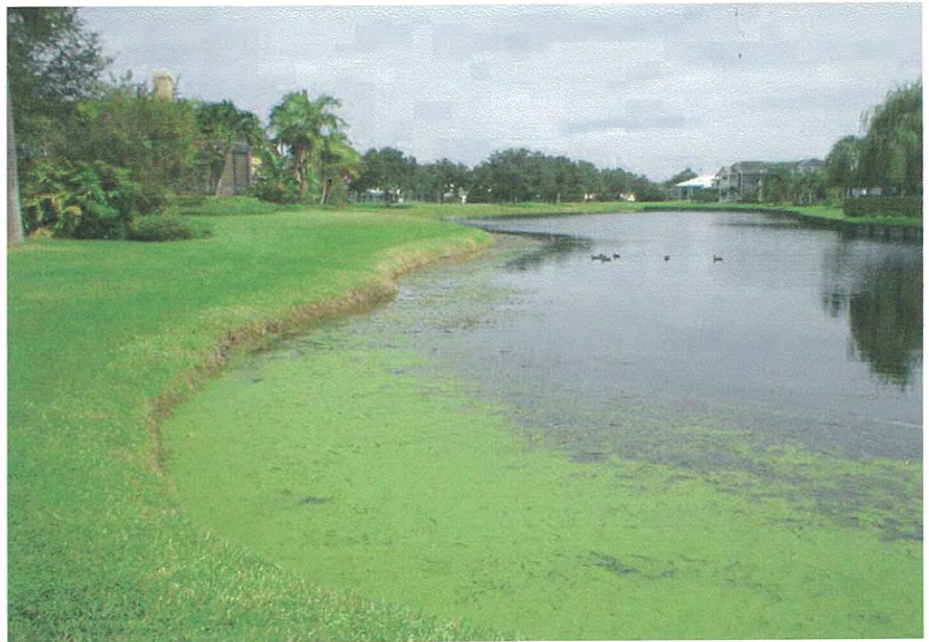
SEGMENT 2

Segment 2: No structures are in immediate risk at this time although it is evident that the lake edge has moved back several feet over the past years. The lake bank in this area has a 3 foot vertical drop at the water's edge. In addition, the slope of the backyards near the water's edge is very steep and show signs of failure. As a result, this area should be both stabilized and restored. The installation of either the Geotextile tube system, the Geoweb cellular confinement system, or the coir rolls system (turtle logs) with a pre-vegetated plant mat is recommended. Additional fill should be added in this area to restore the lake bank to near original conditions. Due to the existing retaining wall at the north end of this segment, construction access may be difficult from the west side of the lake. Access would have to be made from the east side of the lake.
