Placido Bayou Community Association Waterway Inspection Report

Reason for Inspection: Customer Request

Inspection Date: 11/26/2014

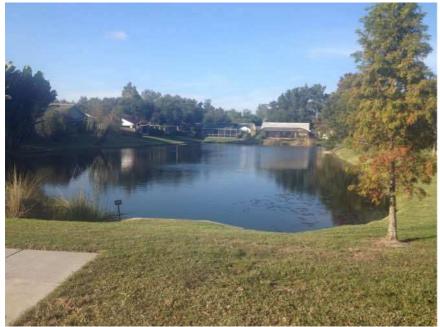
Comments: Site looks good

This site will continue to be monitored for areas of decomposing bulrush until such time as a removal is deemed necessary. No other issues present at this time.

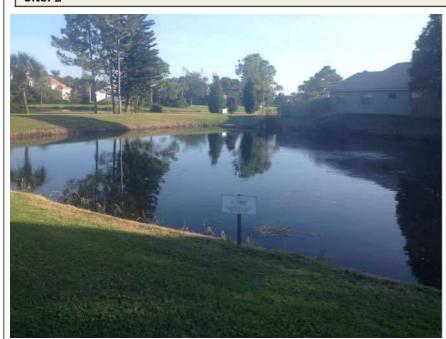
Site: 2

Comments: Site looks good

New plants seem to be doing well in this site. Oxidizer and digester enzyme regiment to begin in December tentatively.

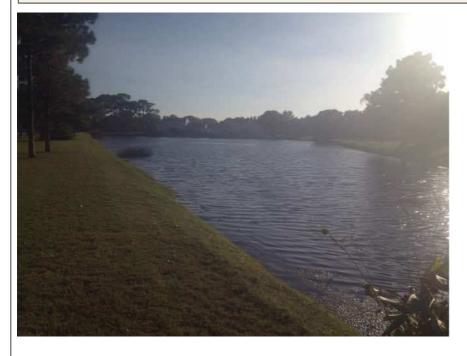
Comments: Site looks good

Trace algae at north end should dissipate after dredging near culvert occurs. Remainder of site is in excellent condition.

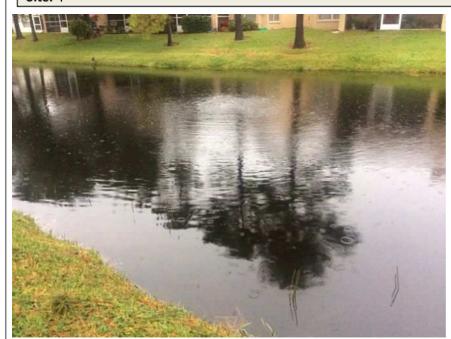
Site: 4

Comments: Site looks good

All new plants appear to be doing well at this time. All areas of decomposing bulrush in this site will continue to be monitored as well until such time as a removal is deemed necessary.

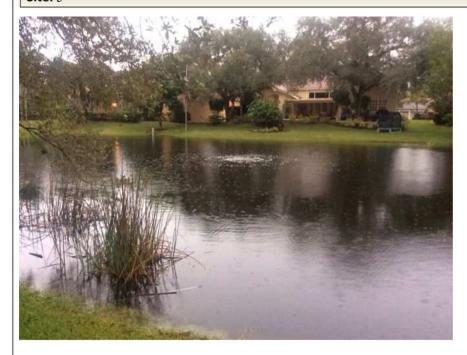
Comments: Site looks good

New plants appear to be doing well. Diffuser can be seen above going strong. Recent rains have elevated water levels to the point where no mow signs are completely submerged.

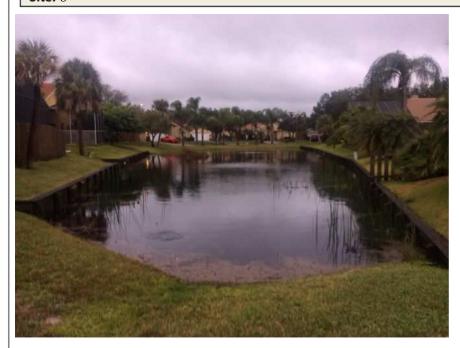
Site: 6

Comments: Requires attention

Joey will work on the clearing of dead material from the floating mat next month. Please see management summary for details regarding photos to right.

As you can see these levels are beginning to rise again slowly. This was presented as a possibility from the beginning due to the extensive use of reclaimed water within the community. Unfortunately, as long as reclaimed water is being utilized we will likely continue to see these levels rise to their previous levels. A perfect example of this happening can be seen in the photos for site #6.

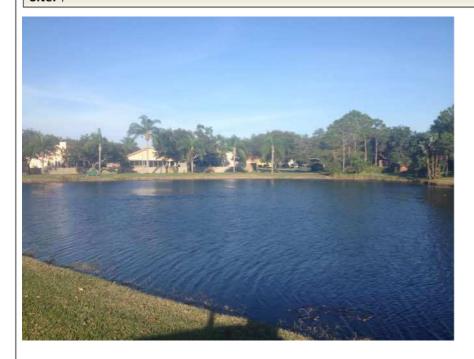
Comments: Site looks good

No algae present at this time. All invasive grasses under control. New aquatic plant growth seems to be doing well. Cypress trees will be monitored until spring for survivability.

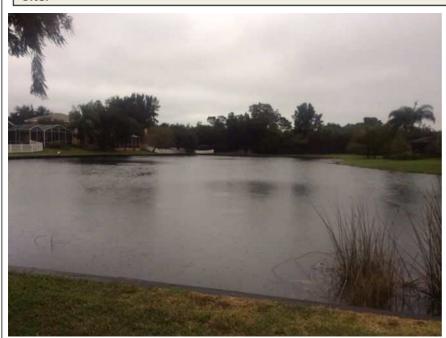
Comments: Site looks good

Trace duckweed present will be treated on next visit. Otherwise site is in excellent condition.

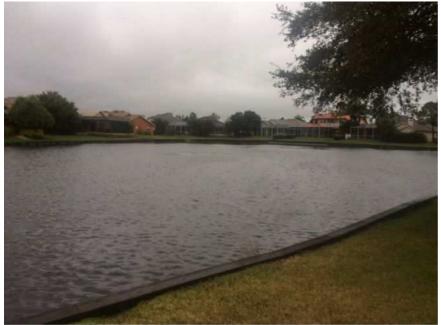
Comments: Site looks good

All aeration systems should be evaluated at regular intervals for health and performance. PBCA recommended for evaluation of all sites at this time. Vertex has been notified.

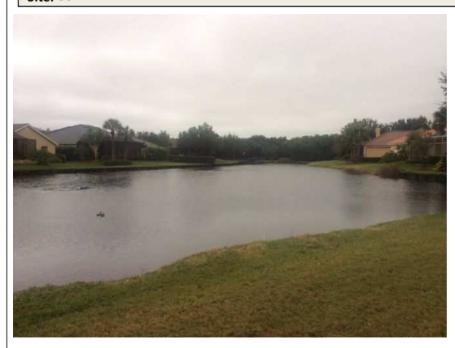
Site: 10

Comments: Site looks good

New plants and mangroves appear to be doing very well.
