PLACIDO BAYOU

PHASE I AND II LAKE BANK RESTORATION & STABILIZATION REPORT

Prepared for:
PLACIDO BAYOU LAKE COMMITTEE

CHARLOTTE ENGINEERING & SURVEYING, INC.

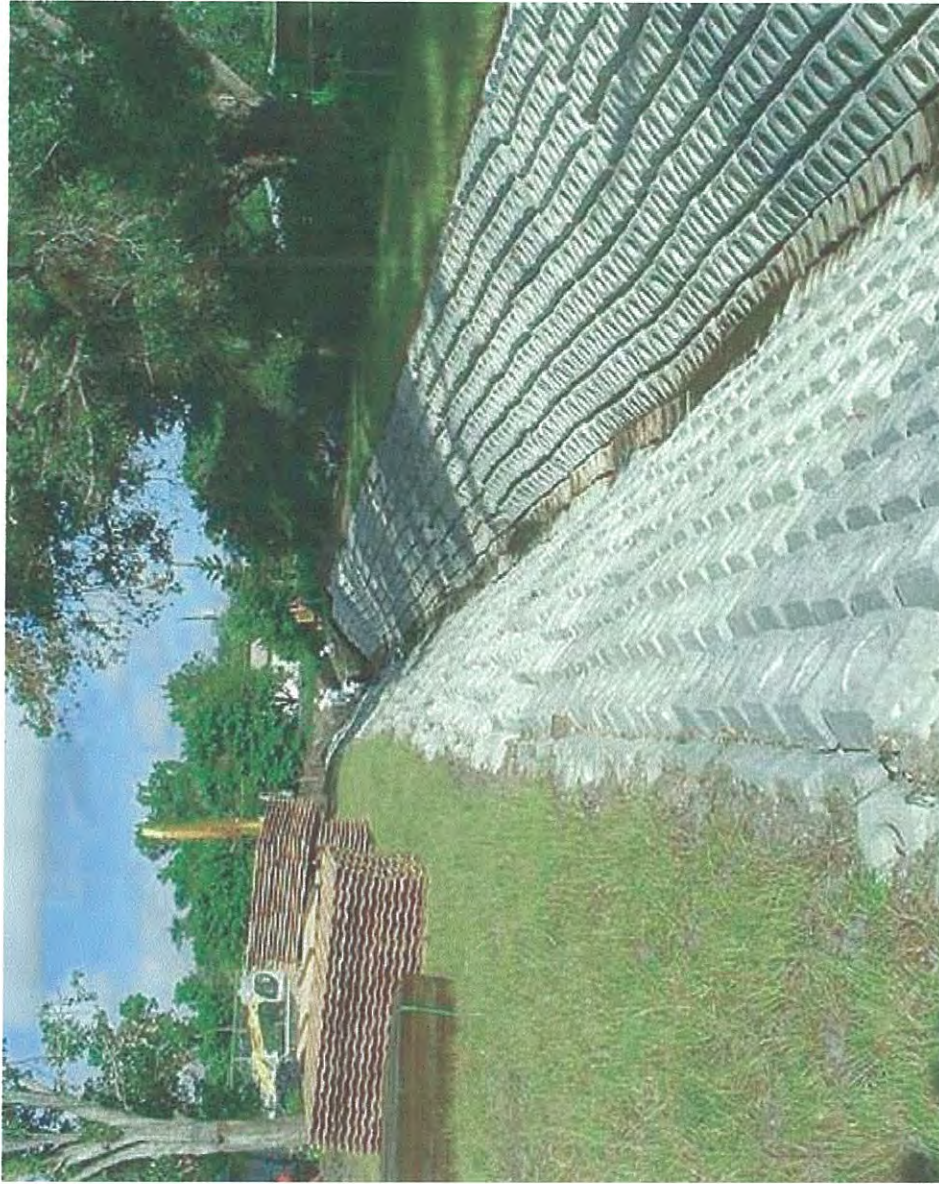
PHOTO 4

Over the years, the natural process of continued bank erosion has occurred. In many locations, the edges of the lakes have expanded by 10 feet or more beyond the original bank edge. Photo 1 shows a typical condition of the eroded lake edge. Note that the grass extends to the water's edge and is being continually undermined by the wave action on the lake. This results in a slow but continued collapse of the lake edge as well as its outward migration. Photo 2 shows a culvert headwall that originally was located at the edge of the lake. Note that the headwall is now 10 feet beyond the existing waters edge. In several of the lakes, the erosion has been so extensive that backyards and pool decks were being undermined. In order to prevent further erosion, the edges of the lakes in many areas have been protected with seawalls. This provides a hard edge to the lakes with no opportunity for vegetation to grow at the waters edge. See Photo 3.

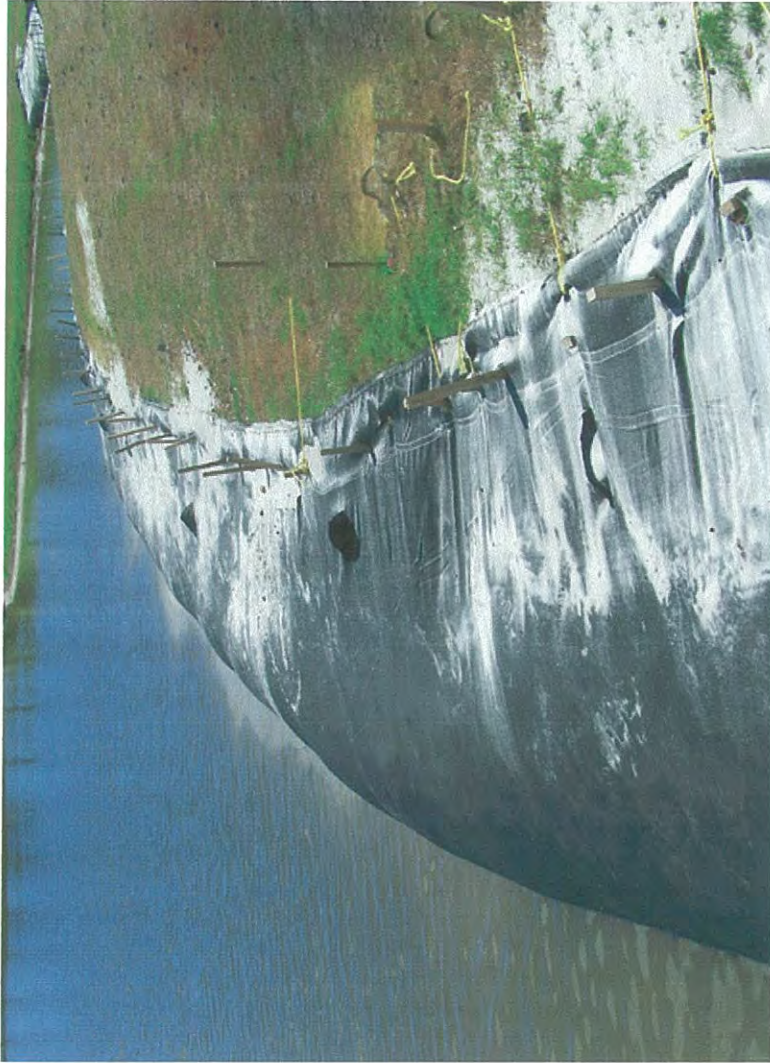
PHOTO 5

STEP 1- INSTALL A LINE OF GEO-TEXTILE TUBE AND TEMPRARY STAKES

This application is very suitable in golf course situations where the lake levels are closely maintained during the dry season through addition of water. See Sheet 4 describing the installation of this product as well as Photos 5 through 7 showing the installation process and final installed condition. The relative ease of installation and minimal disturbance during construction needs to be weighed against the long-term maintenance costs. Expected installed costs for this alternative are in the range of \$50 per linear foot.

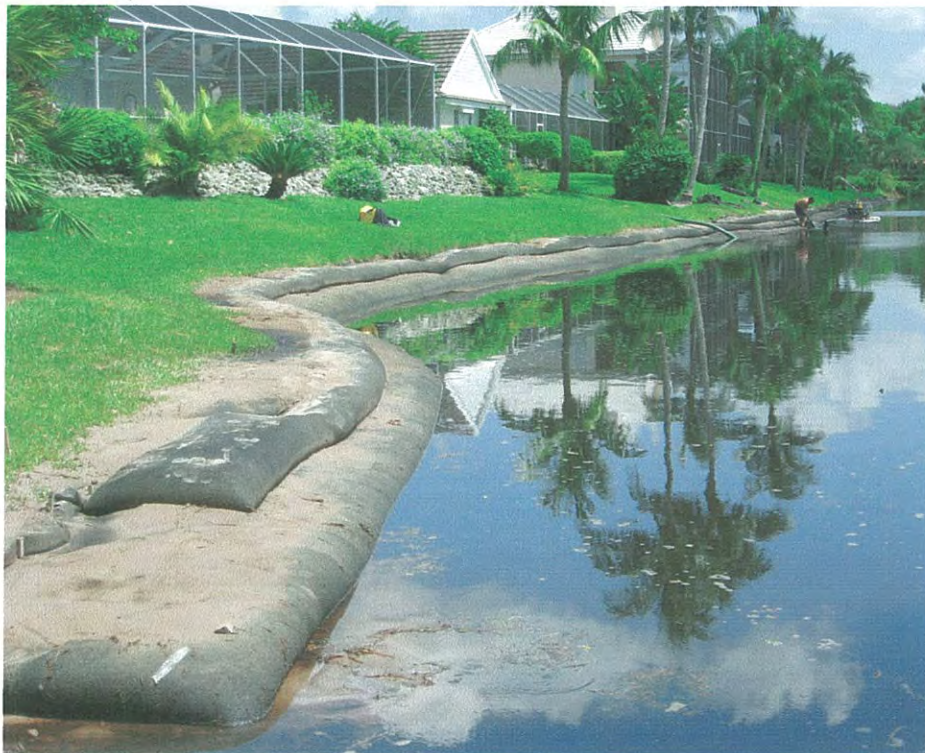
PHOTO 6

STEP 2- INSTALL A FINAL BACK FILL TUBE ON TOP

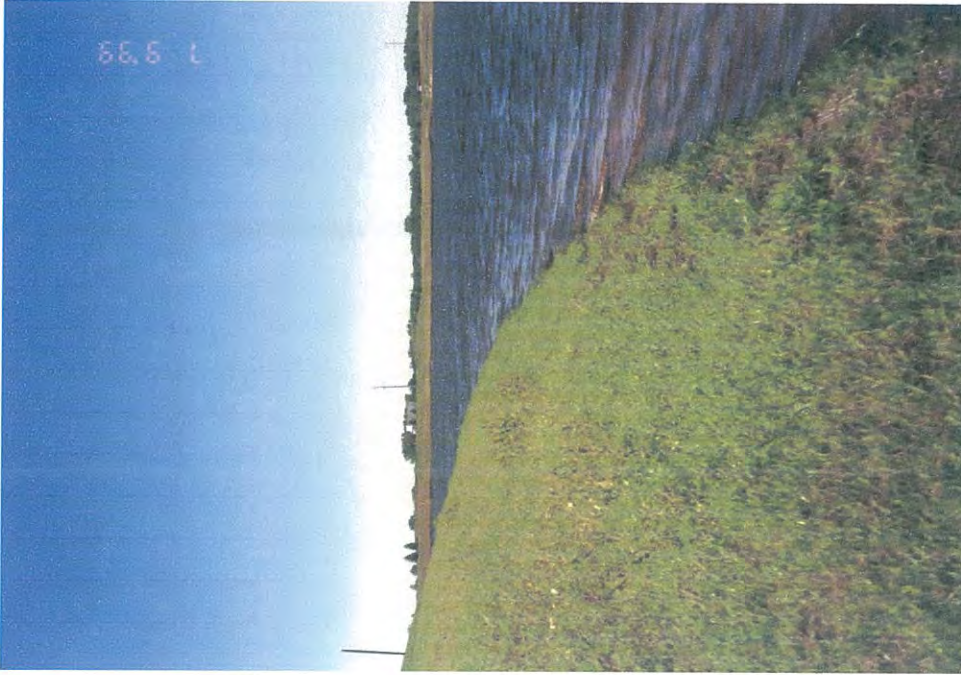
PHOTO 12

STEP 3- FINAL

See Sheet 11 describing the installation process, and Photos 11 and 12 showing the installation process and the final installed condition. The installed costs of this alternative are in the range of \$25 per linear foot.

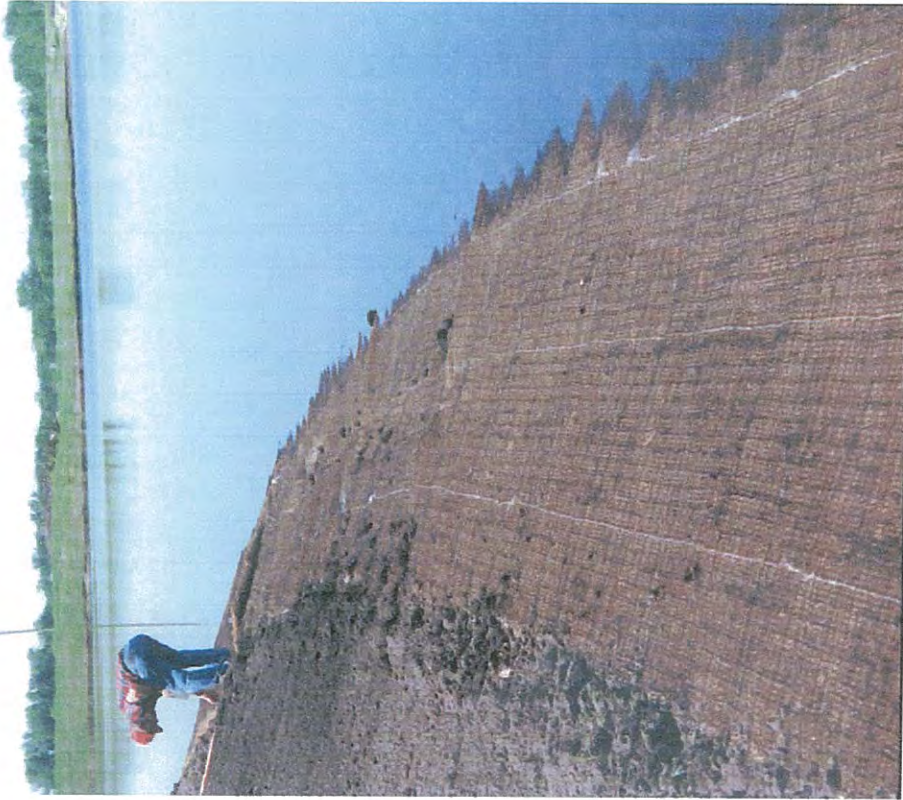
PHOTO 11

STEP 2- DURING RESTORATION

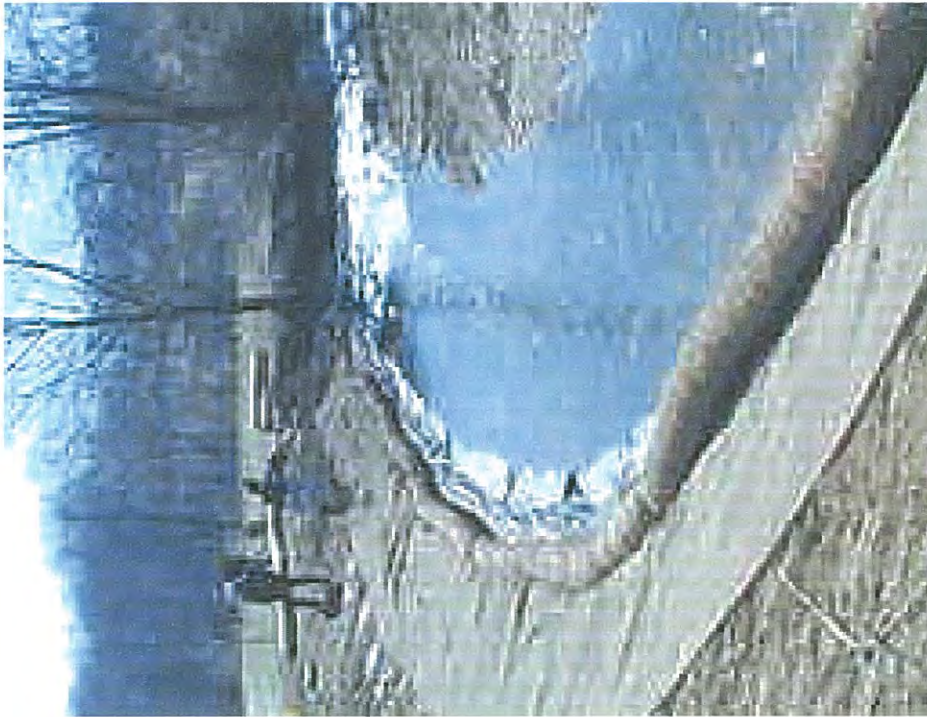
PHOTO 13

DURING RESTORATION

See Sheet 13 describing the installation process, and Photos 13 and 14 showing the installation process and the final installed condition. The installed costs of this alternative are in the range of \$10 per linear foot.

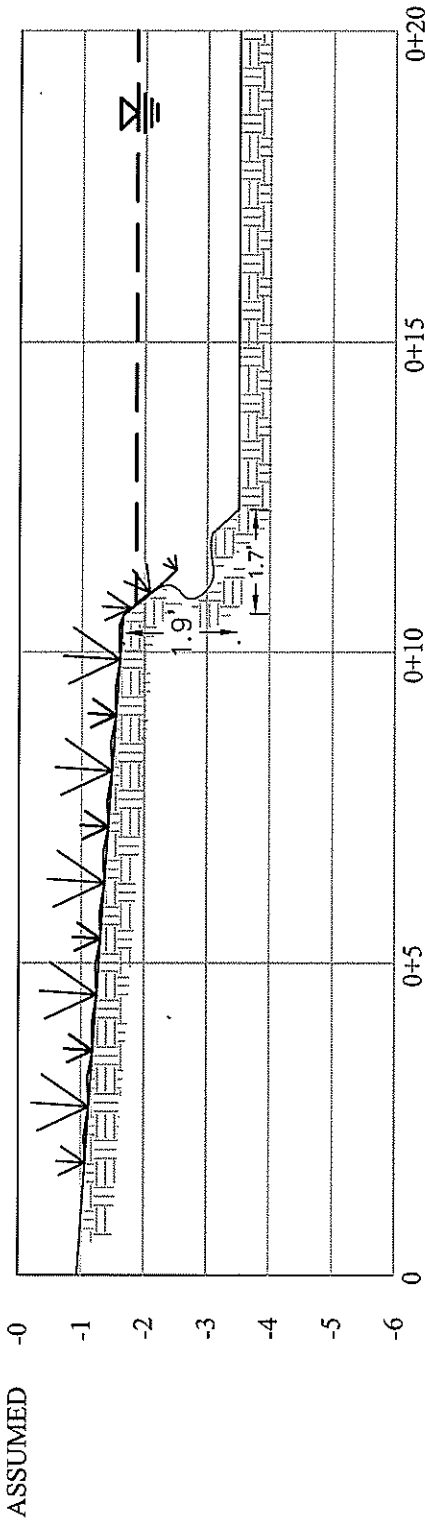
LAKE LUCERNE
CROSS SECTION-3

As part of the data collection, an existing conditions survey of the banks of Lake Lucerne and Lake Messina was performed. Numerous cross sections were surveyed to establish the existing bank profile. This survey data shows that the bank at the lake edge is near vertical and is continuing to fail. Photos were taken to document these conditions. Cross sections of the existing bank edge and typical photographs are provided in the appendix of the report.

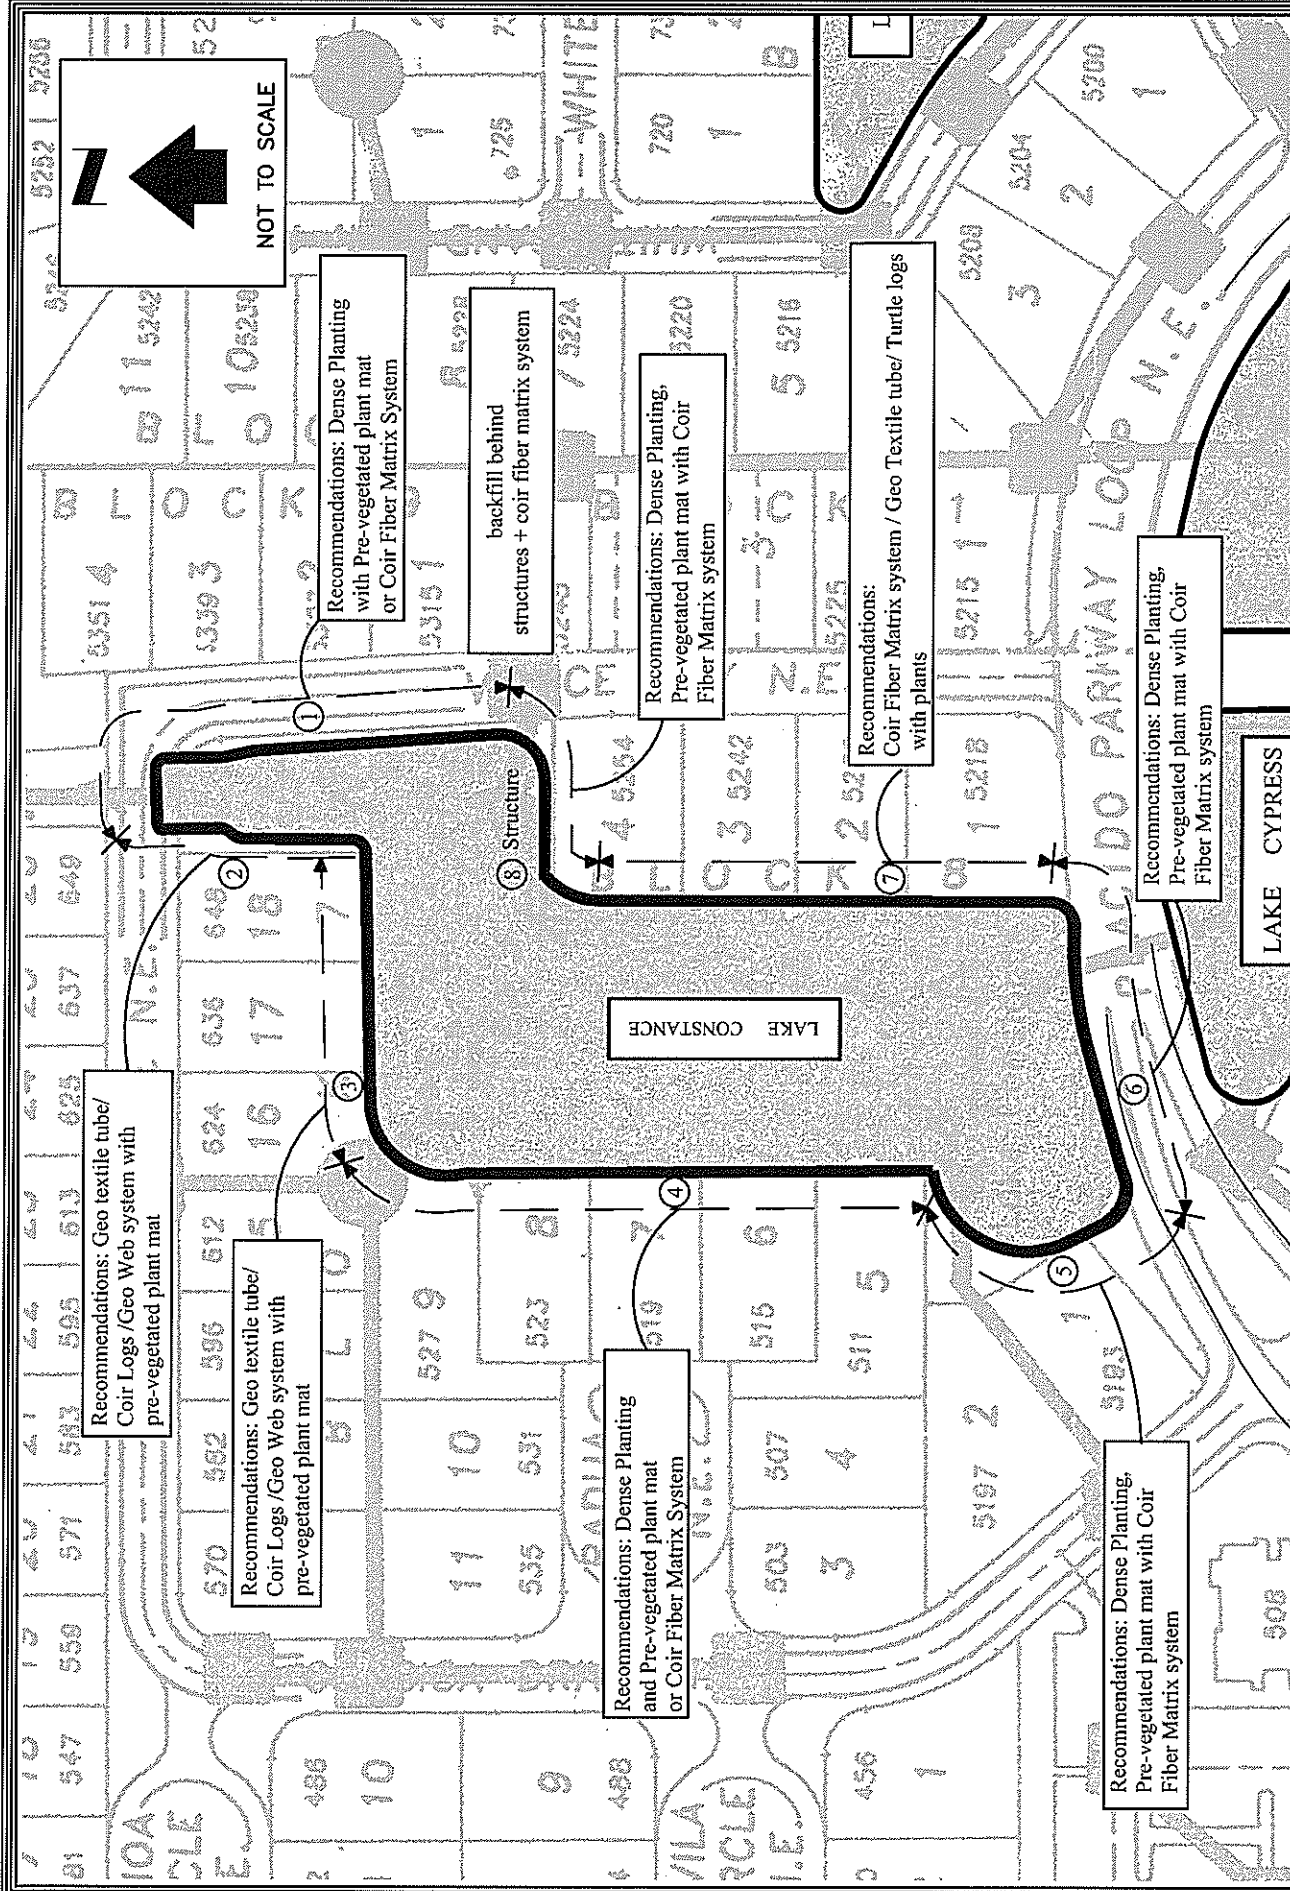
LAKE CONSTANCE
LAKE BANK RESTORATION & STABILIZATION

Segment 2: A residential structure is in close proximity to the lake edge along this segment of the lake. The erosion in this area has created a 3 foot vertical drop at the water's edge. As a result of these conditions, this area needs to be both stabilized and restored. The installation of either the Geotextile tube system, the Geoweb cellular confinement system, or the coir rolls system (turtle logs) with a pre-vegetated plant mat is recommended. Additional fill should be added in this area to restore the lake bank to near original conditions. This area has adequate room for construction access.

Segment 3: No structures are in immediate risk at this time although it is evident that the lake edge has moved back several feet over the past years. The lake bank in this area has a 2 to 3 foot vertical drop at the water's edge. In addition, the slopes of the backyards in this area are fairly steep. As a result, this area should be both stabilized and restored. The installation of either the Geotextile tube system, the Geoweb cellular confinement system, or the coir rolls system (turtle logs) with a pre-vegetated plant mat is recommended. Additional fill should be added in this area to restore the lake bank to near original conditions. This area has limited room for construction access through Segment 2. It was also noted that the headwall structure in this area appears to be displaced and should be stabilized.

Segment 4: The edge of the lake in this segment is moderately eroded. No structures are in immediate risk and the backyard slopes in this segment are not as steep as the backyard slopes in Segment 3. Due to these conditions, dense planting and a pre-vegetated plant mat or the coir fiber matrix system should be installed to prevent further loss of bank material.

Segment 5: The edge of the lake in this segment is moderately eroded. No structures are in immediate risk and the backyard slopes in this segment are not as steep as the backyard slopes in Segment 3. Due to these conditions, dense planting and a pre-vegetated plant mat or the coir fiber matrix system should be installed to prevent further loss of bank material.

Segment 7: No structures are in immediate risk at this time although it is evident that the lake edge has moved back several feet over the past years. The lake bank in this area has a 2 to 3 foot vertical drop at the water's edge. In addition, the slopes of the backyards in this area are very steep. As a result, this area should be both stabilized and restored. The installation of either the Geotextile tube system, the Geoweb cellular confinement system, or the coir rolls system (turtle logs) with a pre-vegetated plant mat is recommended. Additional fill should be added in this area to restore the lake bank to near original conditions. Due to the steepness of the lake bank in this segment, construction access may be difficult.

Segment 8: The edge of the lake in this segment is moderately eroded; the road along this segment is not in immediate risk. Dense planting and a pre-vegetated plant mat or the coir fiber matrix system should be installed to prevent further loss of bank material. The existing headwall structure requires backfill and stabilization to prevent further deterioration.

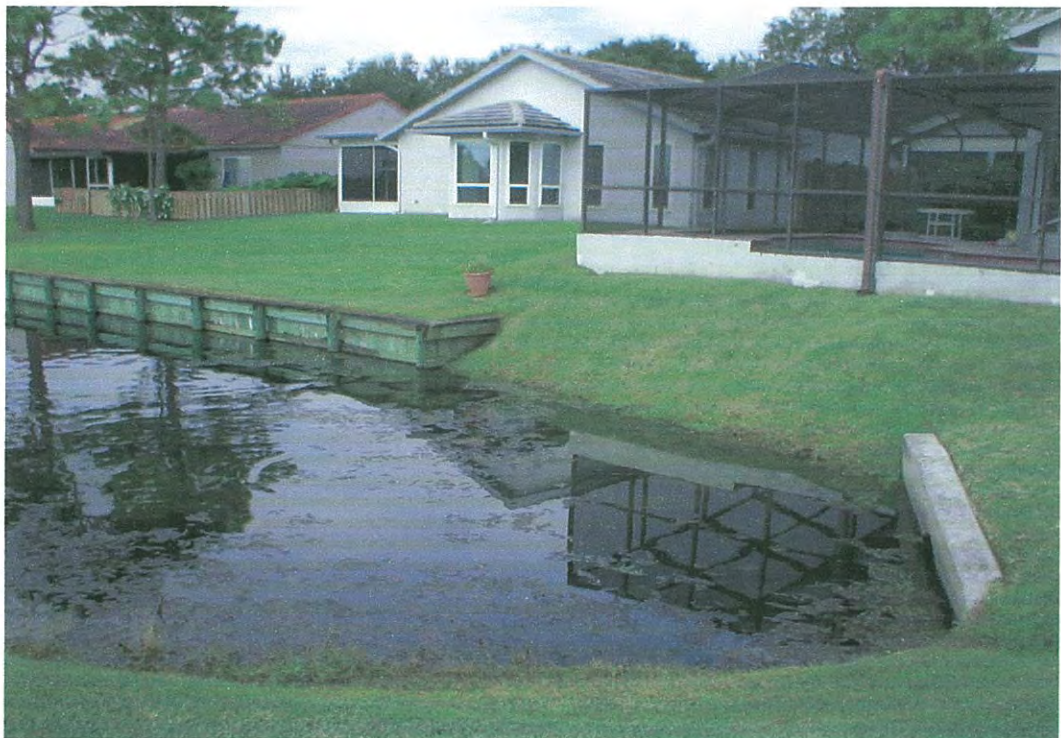
SEGMENT 2

Segment 2: A residential structure is in close proximity to the lake edge along this segment of the lake. The erosion in this area has created a 3 foot vertical drop at the water’s edge. As a result of these conditions, this area needs to be both stabilized and restored. The installation of either the Geotextile tube system or the Geoweb cellular confinement system with a pre-vegetated plant mat is recommended. Additional fill should be added in this area to restore the lake bank to near original conditions. This area has adequate room for construction access.

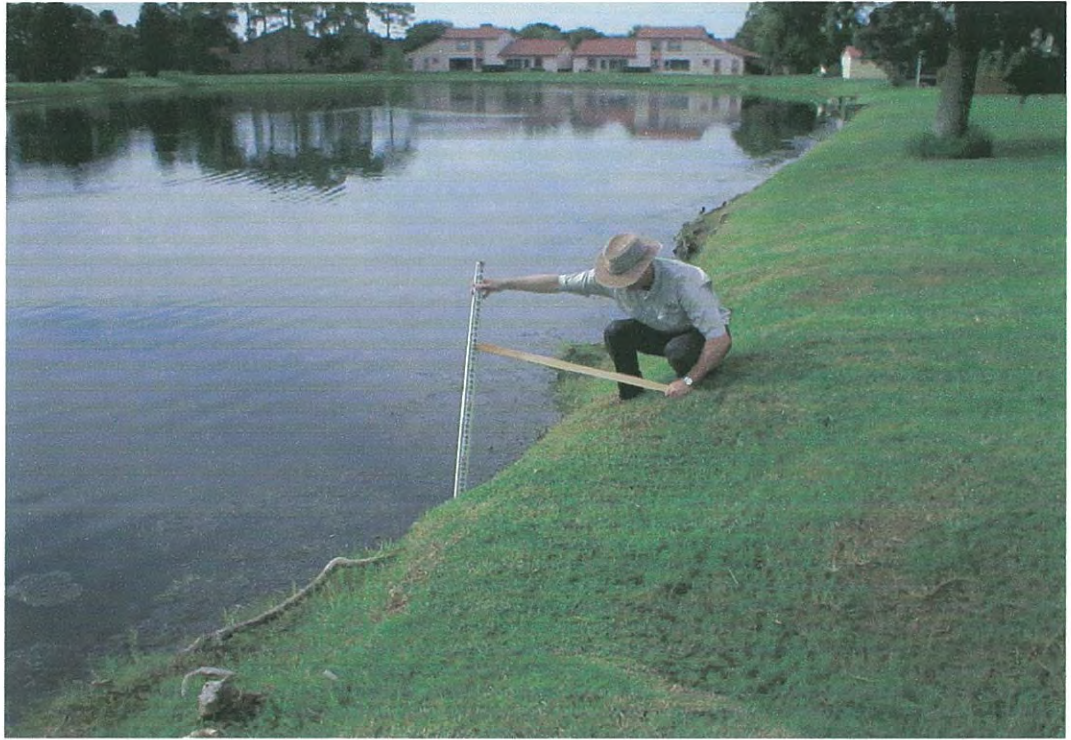
SEGMENT 3

Segment 3: No structures are in immediate risk at this time although it is evident that the lake edge has moved back several feet over the past years. The lake bank in this area has a 2 to 3 foot vertical drop at the water’s edge. In addition, this area is between two segments of the lake where vertical retaining walls have been constructed. As a result, this area should be both stabilized and restored. The installation of either the Geotextile tube system, the Geoweb cellular confinement system, or the coir rolls system (turtle logs) with a pre-vegetated plant mat is recommended. Additional fill should be added in this area to restore the lake bank to near original conditions. This area has limited room for construction access. It was also noted that the headwall structure in this area appears to be displaced and should be stabilized.

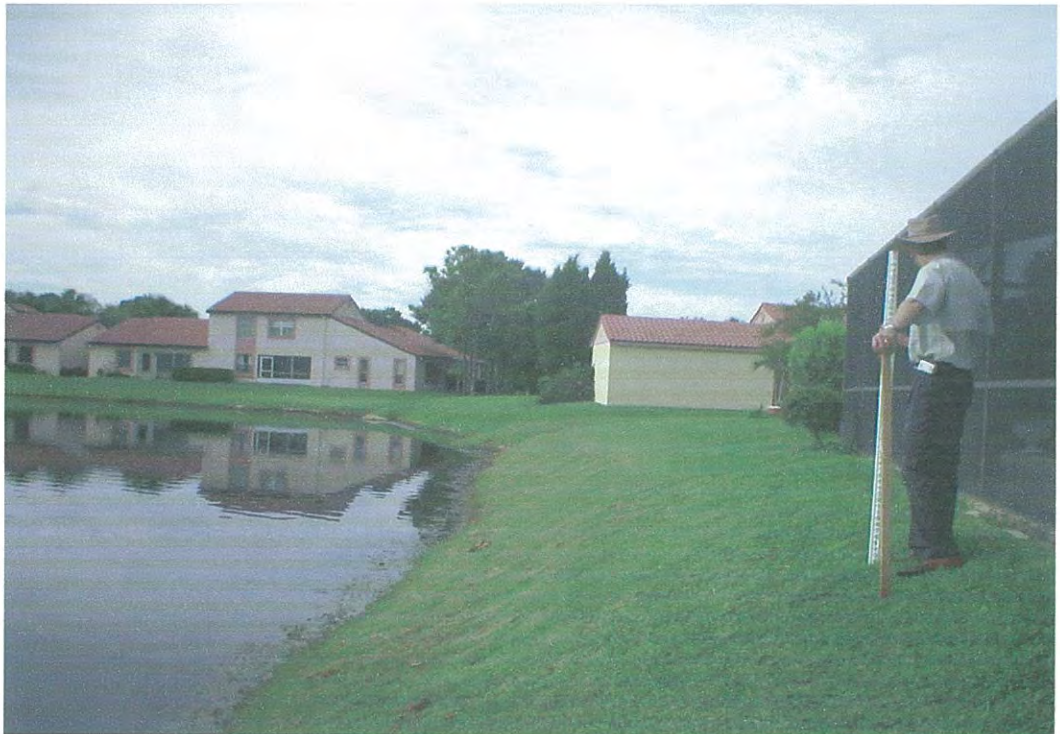
SEGMENT 4

Segment 4: No structures are in immediate risk at this time although it is evident that the lake edge has moved back several feet over the past years. The lake bank in this area has a 4 foot vertical drop at the water’s edge. In addition, this area is adjacent to a segment of the lake where a vertical retaining wall has been constructed. As a result, this area should be both stabilized and restored. The installation of either the Geotextile tube system, the Geoweb cellular confinement system, or the coir rolls system (turtle logs) with a pre-vegetated plant mat is recommended. Additional fill should be added in this area to restore the lake bank to near original conditions. This area has limited room for construction access.

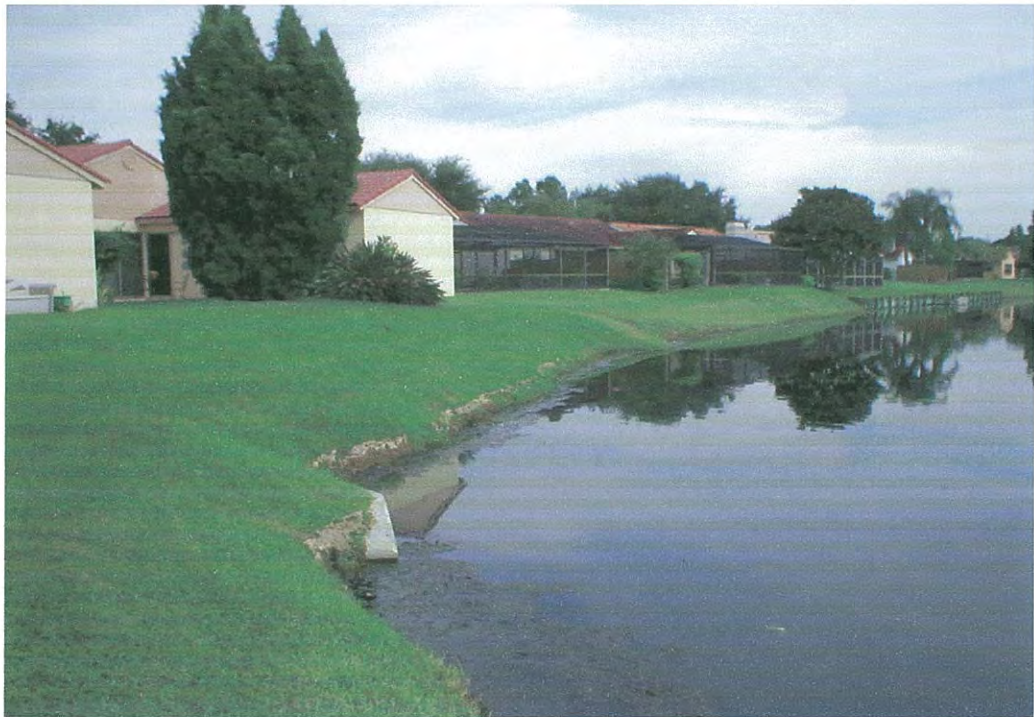
SEGMENT 5

Segment 5: No structures are in immediate risk at this time although it is evident that the lake edge has moved back several feet over the past years. The lake bank in this area has a 3 foot vertical drop at the water's edge. In addition, the slopes of the backyards in this area are very steep. As a result, this area should be both stabilized and restored. The installation of either the Geotextile tube system, the Geoweb cellular confinement system, or the coir rolls system (turtle logs) with a pre-vegetated plant mat is recommended. Additional fill should be added in this area to restore the lake bank to near original conditions. Due to the steepness of the lake bank in this segment, construction access may be difficult.

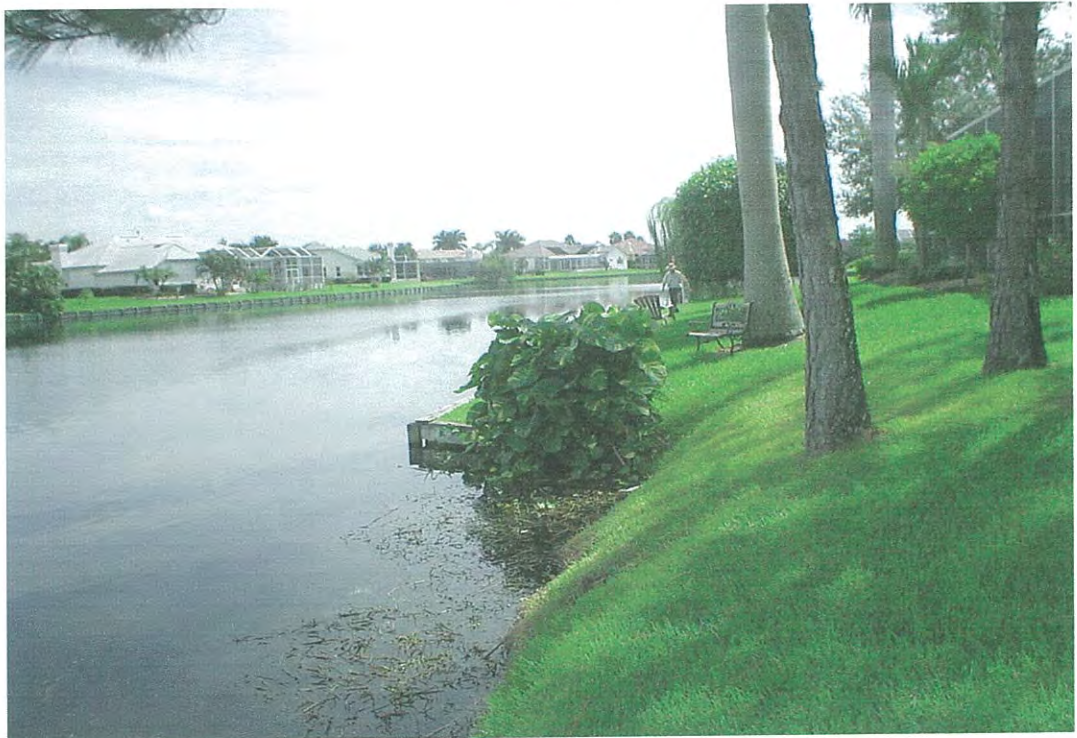
SEGMENT 2

Segment 2: No structures are in immediate risk at this time although it is evident that the lake edge has moved back approximately 8 feet over the past years. The lake bank in this area has a 2 to 3 foot vertical drop at the water’s edge. In addition, this area is adjacent to a segment of the lake where a vertical retaining wall has been constructed. Due to the proximity of the wall, either a continuation of the wall or the Geoweb cellular confinement system is recommended for this segment. Additional fill should be added in this area to restore the lake bank to near original conditions. This area has limited room for construction access.

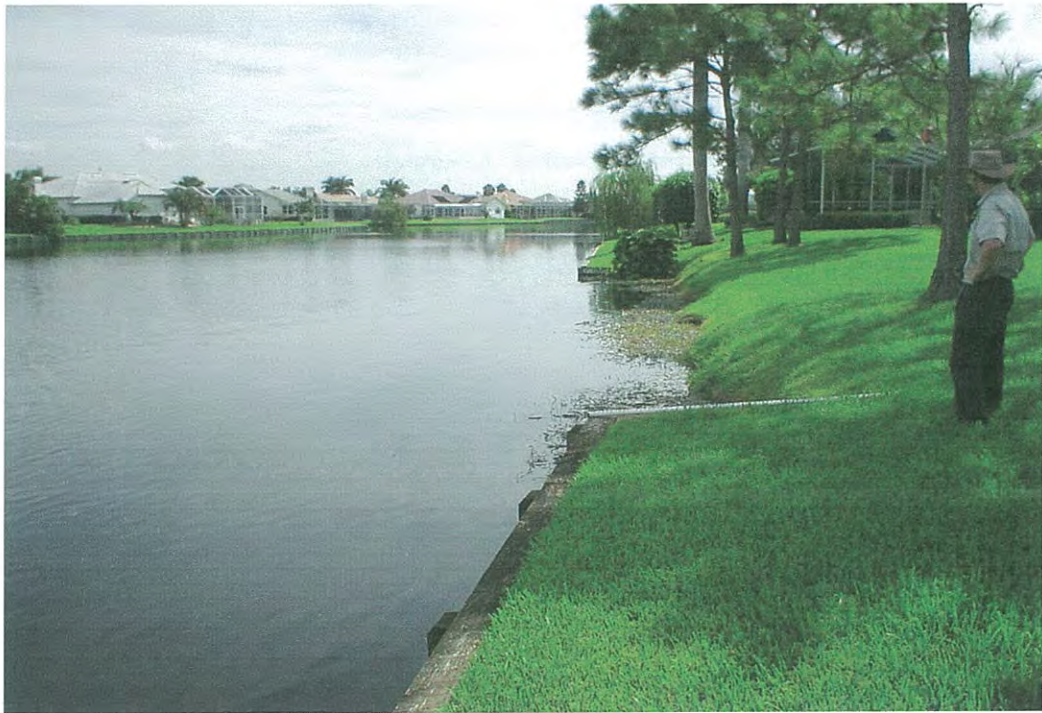
SEGMENT 3

Segment 3: No structures are in immediate risk at this time although it is evident that the lake edge has moved back approximately 12 feet over the past years. The lake bank in this area has a 3 foot vertical drop at the water’s edge. In addition, this area is between two segments of the lake where vertical retaining walls have been constructed. Due to the short section of unprotected lake edge, a continuation of the retaining wall is recommended for this segment. Additional fill should be added in this area to restore the lake bank to near original conditions. This area has very limited room for construction access.

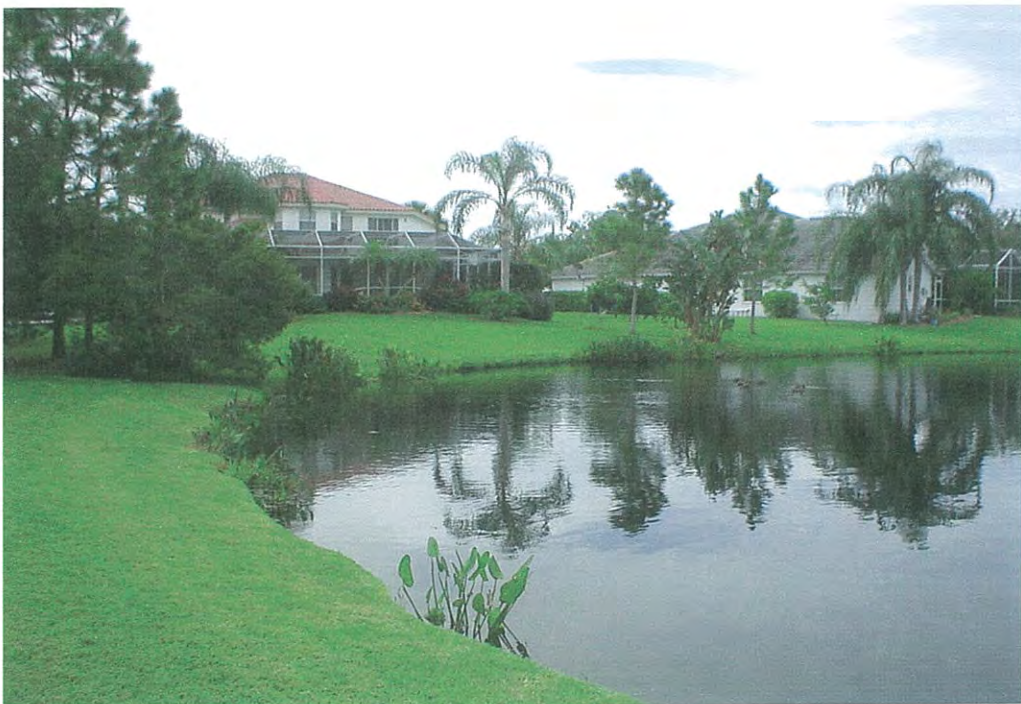
SEGMENT 4

Segment 4: The edge of the lake in this segment is moderately eroded; no structures are in immediate risk. The slope of the backyards in this segment is relatively flat. Dense planting installed along the shoreline should be sufficient to prevent further loss of bank material.

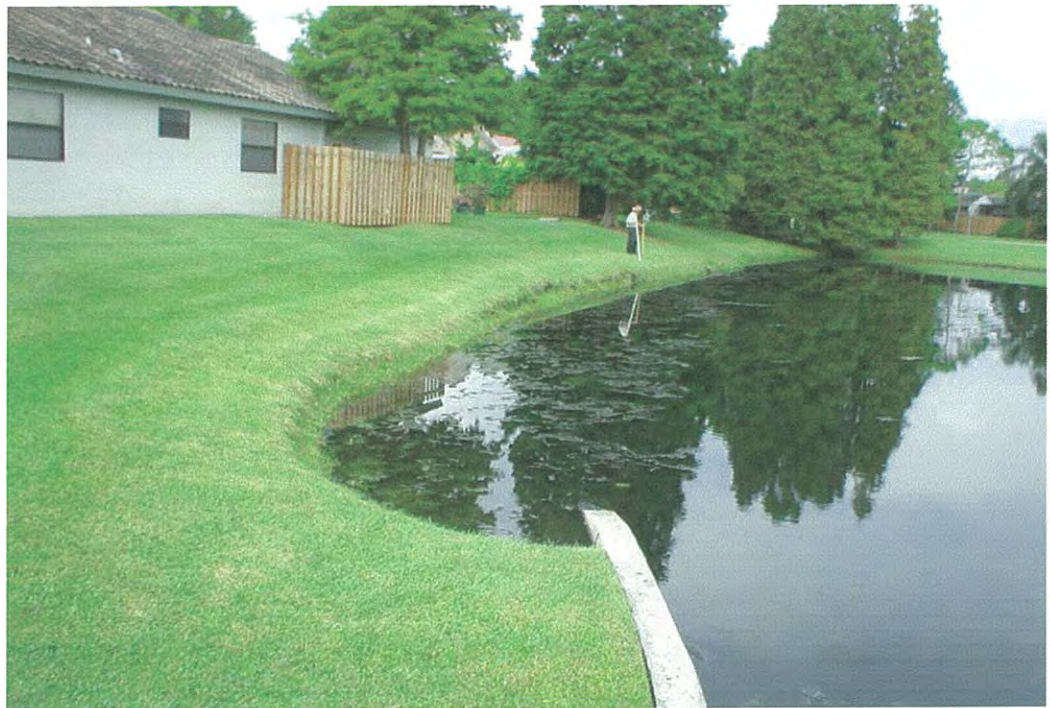
SEGMENT 2

Segment 2: No structures are in immediate risk at this time although it is evident that the lake edge has moved back several feet over the past years. The lake bank in this area has a 3 foot vertical drop at the water’s edge. In addition, the slopes of the side yard in this area are very steep. As a result, this area should be both stabilized and restored. The installation of either the Geotextile tube system, the Geoweb cellular confinement system, or the coir rolls system (turtle logs) with a pre-vegetated plant mat is recommended. Additional fill should be added in this area to restore the lake bank to near original conditions. Due to the steepness of the lake bank in this segment, construction access may be difficult.

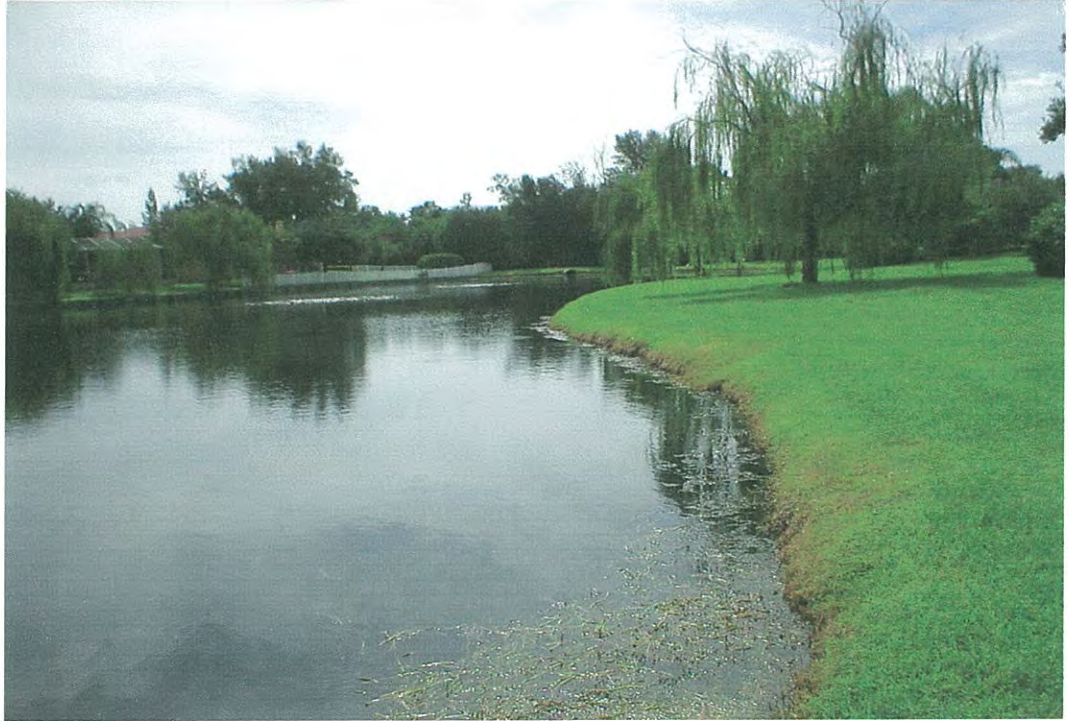
GENERAL VIEW

Over fifty percent of this lake has been protected with pressure-treated wood retaining walls. The unprotected side of the lake is only moderately eroded; no structures are in immediate risk. The slopes of the backyards in this segment are relatively flat. Dense planting installed along the shoreline should be sufficient to prevent further loss of bank material.

It should be noted that the outfall pipe from this lake has no control weir that prevents backwater flow from increased tide levels. It was also noted that a bracket for a weir plate (aka: threshold sill) was attached to the outfall pipe. During the field inspection, it was noted that grasses along the shoreline were dead. This was likely due to salt water backflow that resulted from the very high tide conditions created during the passage of Hurricane Ike. A small weir plate, or threshold sill should be installed to prevent future backflow of tidal water into the lake.

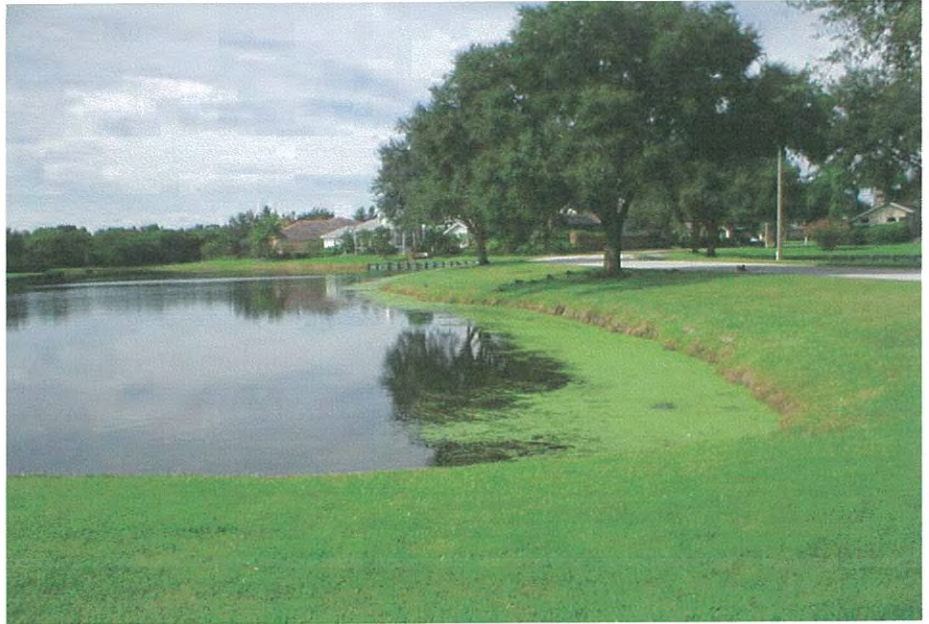
SEGMENT 1

Segment 1: The edge of the lake in this segment is moderately eroded; the road along this segment is not in immediate risk. Dense planting and a pre-vegetated plant mat or the coir fiber matrix system should be installed to prevent further loss of bank material.

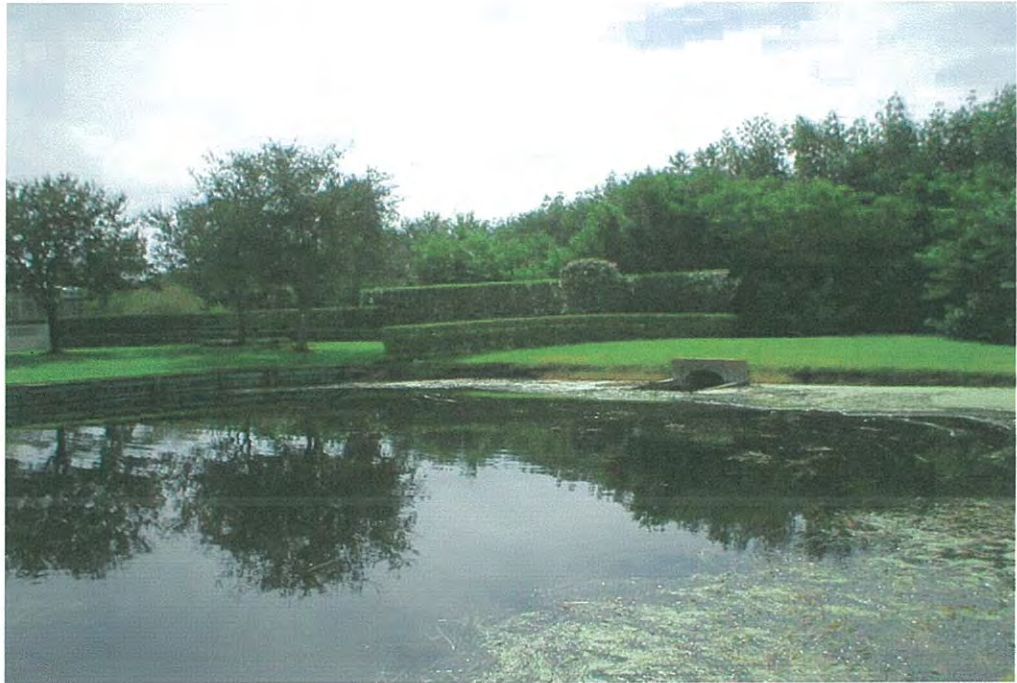
STRUCTURE SEGMENT 2

Segment 2: No structures are in immediate risk at this time although it is evident that the lake edge has moved back several feet over the past years. The lake bank in this area has a 3 foot vertical drop at the water's edge. In addition, the slope of the backyards near the water's edge is very steep and show signs of failure. As a result, this area should be both stabilized and restored. The installation of either the Geotextile tube system, the Geoweb cellular confinement system, or the coir rolls system (turtle logs) with a pre-vegetated plant mat is recommended. Additional fill should be added in this area to restore the lake bank to near original conditions. Due to the existing retaining wall at the north end of this segment, construction access may be difficult from the west side of the lake. Access would have to be made from the east side of the lake.
